Figure 1.1  
 Cross Sectional View of Water Tank  
 with Cathodic Protection

TITLE:	CATHODIC PROTECTION	
CLIENT:	HARVEY DURSTON - RHINO TANKS	
DATE:	09/03/07	SHEET 1 OF 3
DRAWN BY:	<b>Matt Harding</b>	NOT TO SCALE

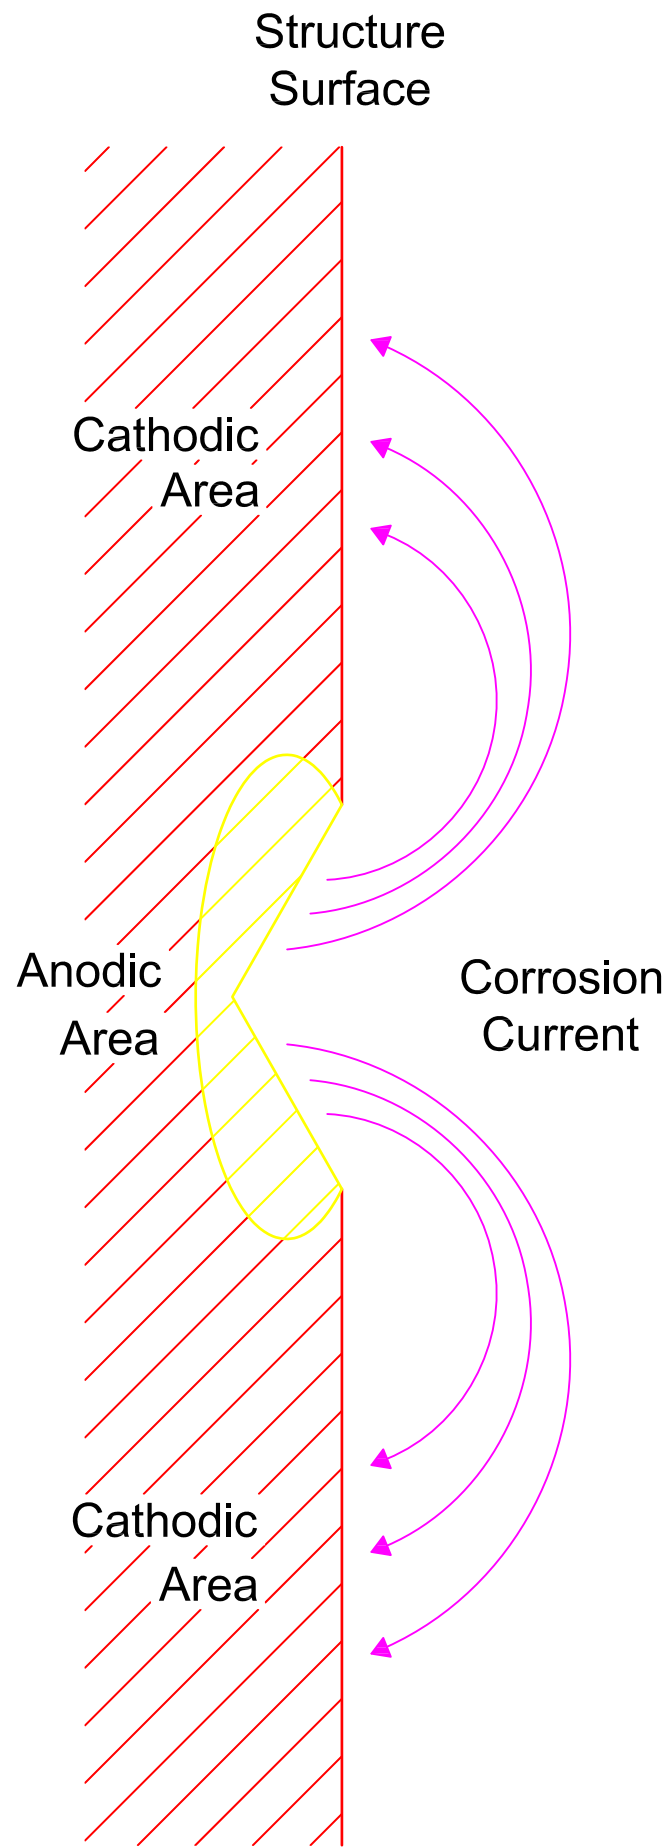
**Figure 1.2**  
Close-up view of the Corrosion Process.

**Overlap of Protective Current for complete coverage.**

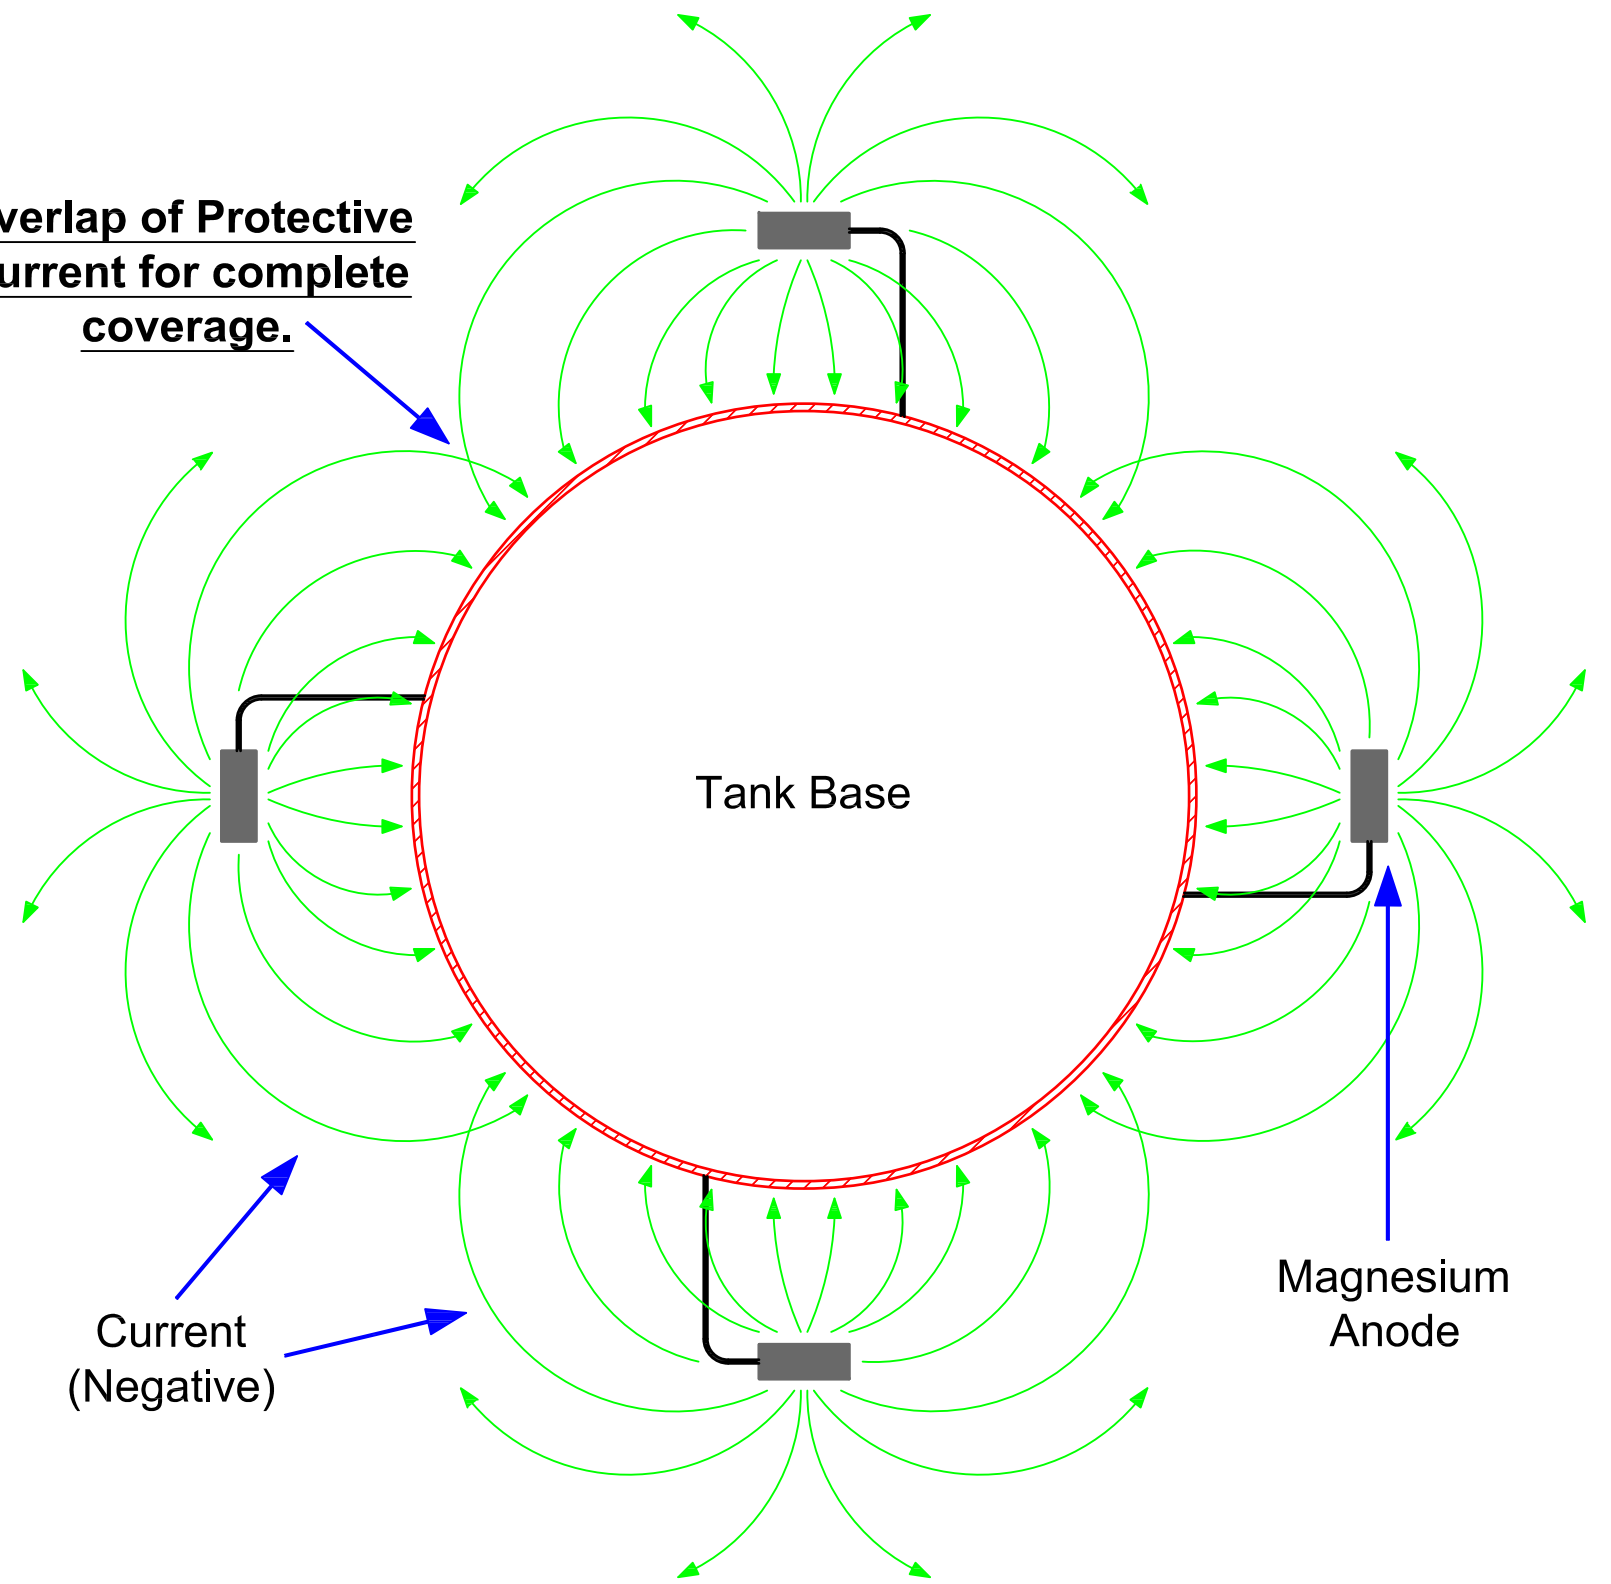
**Figure 1.3**  
Top View - Base of Tank with Cathodic Protection

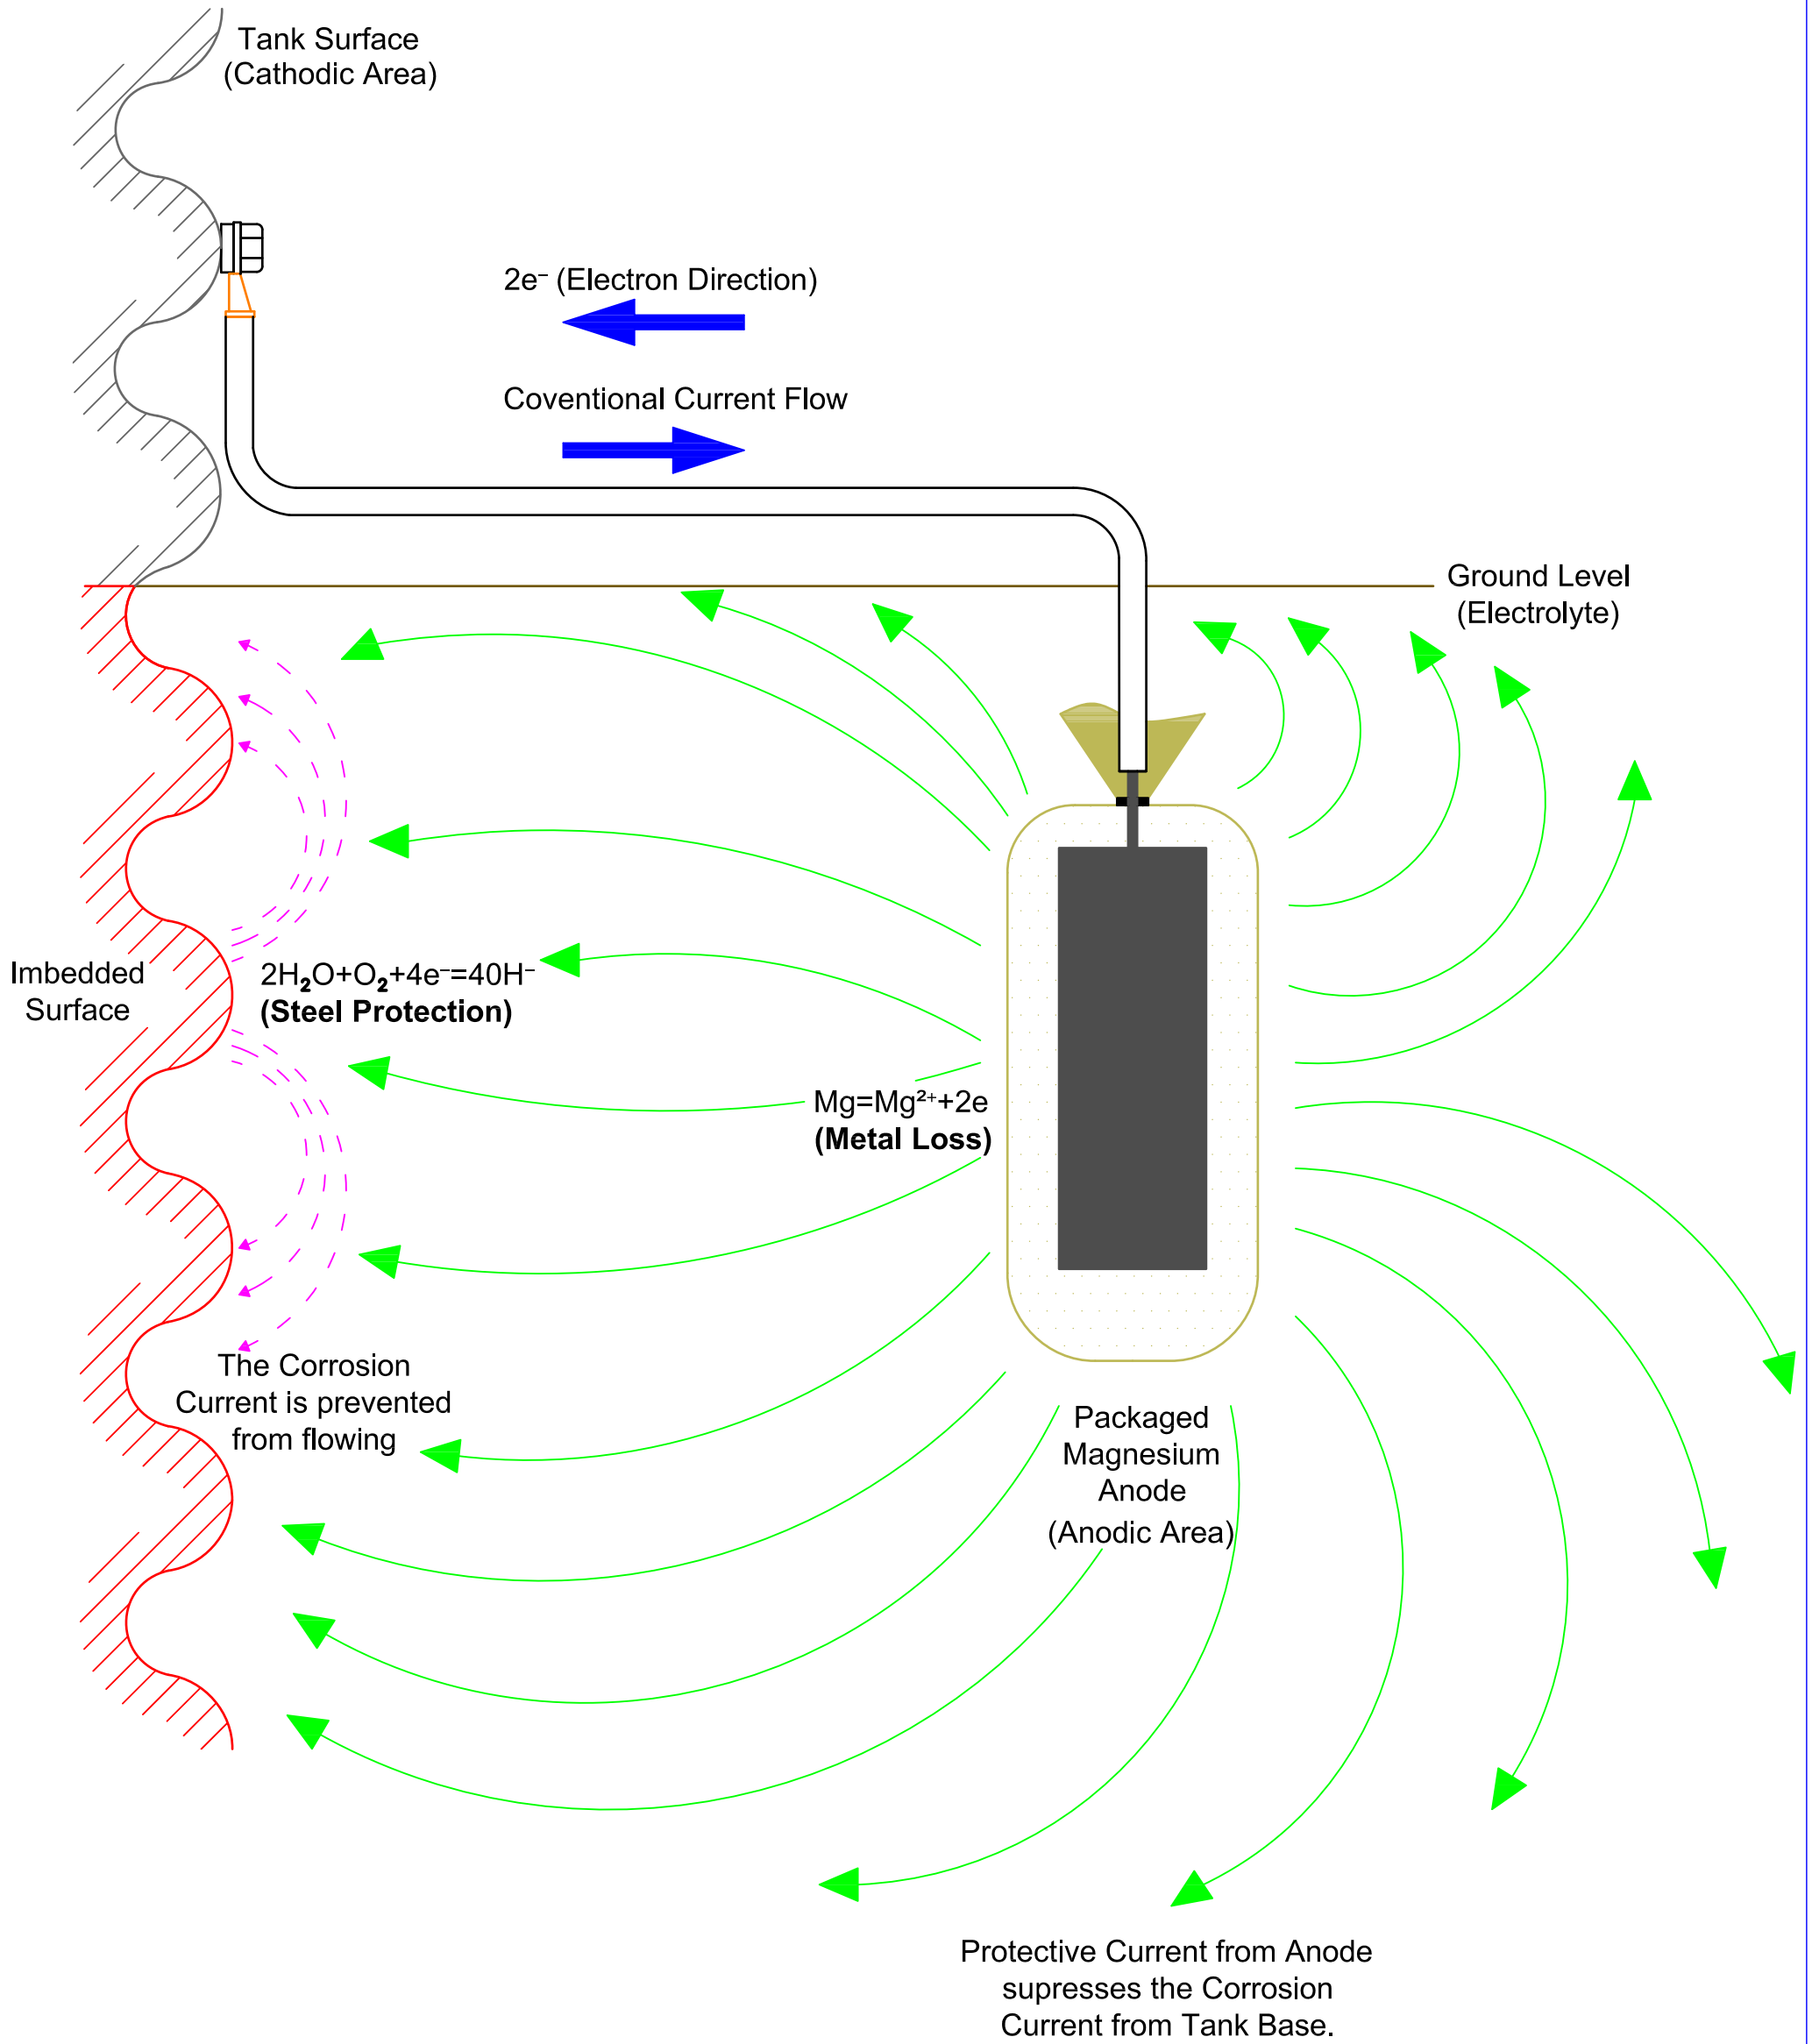
**Figure 1.4**  
Close-up view of the Tanks base with Cathodic Protection.
